DEPARTMENT OF TRANSPORTATION**DIVISION OF ENGINEERING SERVICES**

Contract #: 04-0120F4Cty: SF/ALA Rte: 80 PM: 13.2/13.9File #: 1.28**WELDING INSPECTION REPORT****Resident Engineer:** Casey, William**Address:** 333 Burma Road**City:** Oakland, CA 94607**Report No:** WIR-028196**Date Inspected:** 15-Aug-2012**Project Name:** SAS Superstructure**OSM Arrival Time:** 1300**Prime Contractor:** American Bridge/Fluor Enterprises, a JV**OSM Departure Time:** 1930**Contractor:** American Bridge/Fluor Enterprises, a JV**Location:** Jobsite**CWI Name:** NA**CWI Present:** Yes No**Inspected CWI report:** Yes No N/A**Rod Oven in Use:** Yes No N/A**Electrode to specification:** Yes No N/A**Weld Procedures Followed:** Yes No N/A**Qualified Welders:** Yes No N/A**Verified Joint Fit-up:** Yes No N/A**Approved Drawings:** Yes No N/A**Approved WPS:** Yes No N/A**Delayed / Cancelled:** Yes No N/A**Bridge No:** 34-0006**Component:** TOWER and OBG**Summary of Items Observed:**

On this date, Quality Assurance Inspector (QAI) Robert A. DeArmond was present at the San Francisco Oakland Bay Bridge job site at Yerba Buena Island to observe erection and welding activities for the San Francisco Oakland Bay Br

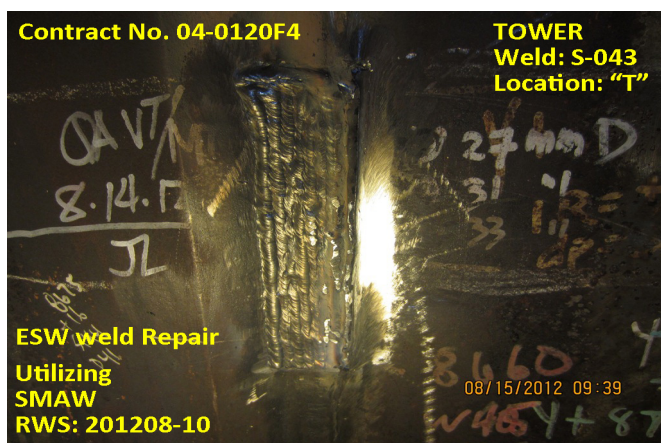
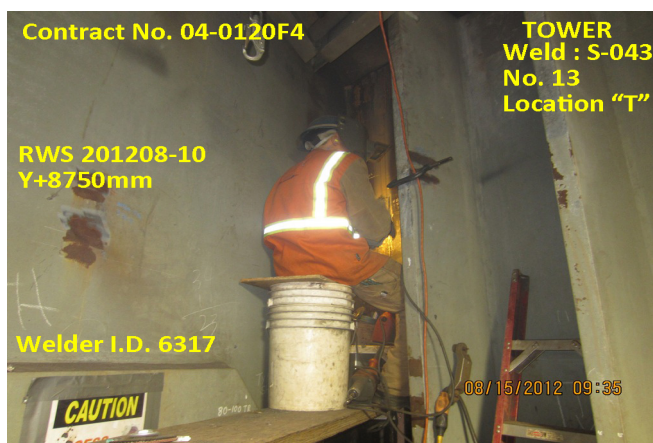
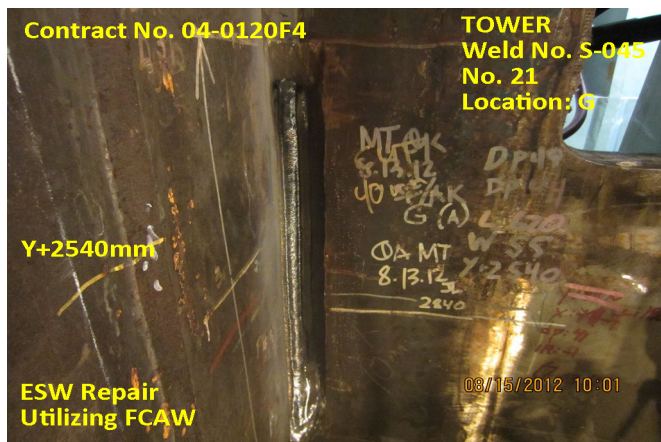
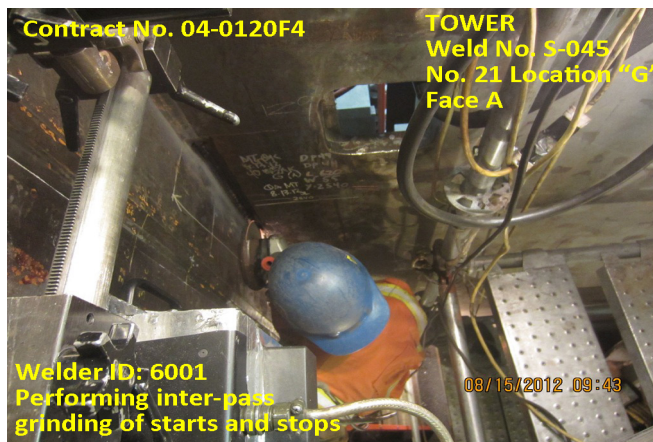
appeared to comply with the AWS Specification and AWS Classification. The QC inspection, testing and welding performed on this shift appeared to be in general compliance with the contract documents. At random intervals, the QAI verified the QC inspection, testing, welding parameters and the surface temperatures utilizing various inspection equipment and gages which included a Fluke 337 Clamp Meter and Tempilstik Temperature indicators. Unless noted otherwise, all work observed on this date appeared to be in general compliance with the contract documents at the time of observations.

The QAI observed that welder 6317-Wen Han Yu, was welding fill and cover passes for ESW repair located at Y+8750 S-043 #13 Location "T". This QAI observed Welding Procedure Specification (WPS) ABF-WPS-D15-1000-Repair and RWR 201208-10 was utilized. The QC inspector Andrew Keech verified the excavation of the repair area as well as Magnetic Particle Testing of the excavation for this location and found it to be acceptable, this information was relayed to the QAI. The welder then continued pre-heat throughout the area during welding utilizing heat racks on the back side of the repair area at 170 degrees Celsius (338 degrees F) which was verified using a tempstik and infrared gun by the QC. The welder was using the Shielded Metal Arc Welding (SMAW) electrode E7018 for the Complete Joint Penetration (CJP) weld in the vertical (3G) position with 3.1 mm electrode for the fill and cove pass. The welder utilized a power grinder and power wire wheel for the interpass cleaning. The QC inspector for this location was Andrew Keech and was observed verifying and

The QAI observed that welder 6001-James Zhen, was welding fill passes for ESW repair located at Y+2540 S-045 #21 Location "G". This QAI observed welding of this location without an approved Welding Procedure Specification (WPS) and / or Repair Welding Specification (RWS) this incident was documented on QC daily report; (VT-102-1) dated August 14, 2012. In addition, QAI Mr. Joselito Lizardo generated an Incident Report for this date .

The QAI observed that welder Lin E Yun was welding the back-weld of plate "G" edge plate to edge plate (13W to 14W). This QAI observed these parameters as defined in Welding Procedure Specification (WPS) ABF-WPS-D15-1040-C. The QC inspector Steve Jenson verified the fit up for this location and found it to be acceptable, this information was relayed to the QAI. The welder then continued pre-heat throughout the area during welding using a propane type weed burner at 40 degrees Celsius (150 degrees F) which was verified using a tempstik and infrared gun by the QC. The welder was using the Shielded Metal Arc Welding (SMAW) electrode E7018 for the Complete Joint Penetration (CJP) weld in the vertical (3G) position with 3.2 mm electrode with 128 amps. The welder utilized a power grinder and power wire wheel for the interpass cleaning. The QC inspector for this location was Steve Jenson and was observed verifying and documenting the welding parameters for this location, along with overseeing the welding operations. At the time METS observation was performed. No issues were noted by the QAI.
